# CALIFORNIA INSTITUTE OF TECHNOLOGY

## **THE VERACRUZ EARTHQUAKE OF 28 AUGUST 1973**

by  
H. Max Irvine

EERL 73-06

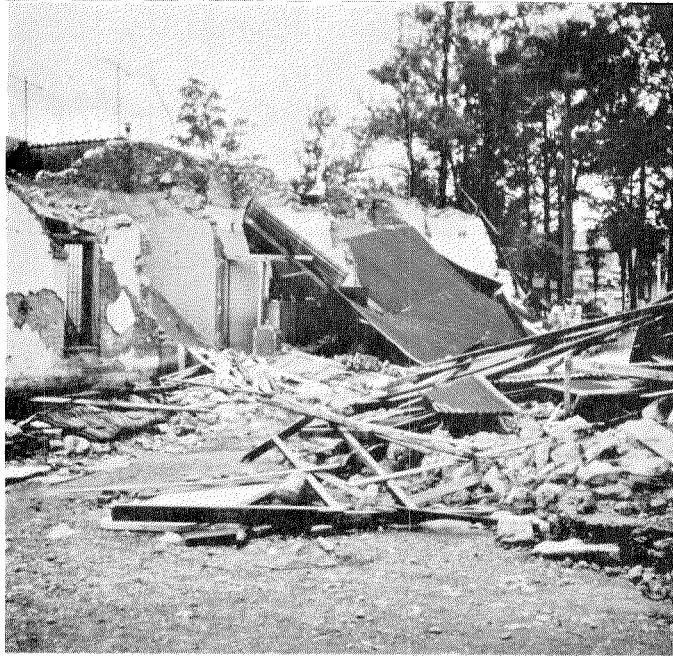
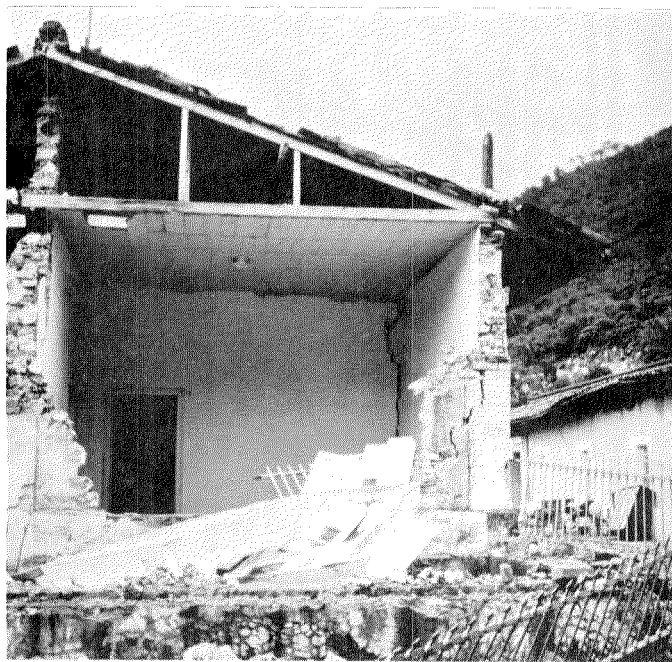
walls were of stone masonry or brick masonry with rather weak mortar. The roofs were either corrugated iron or tile. Figures 3 and 4 (p.17) show typical damage to housing.

Figure 4 Typical damage to housing in Rio Blanco.

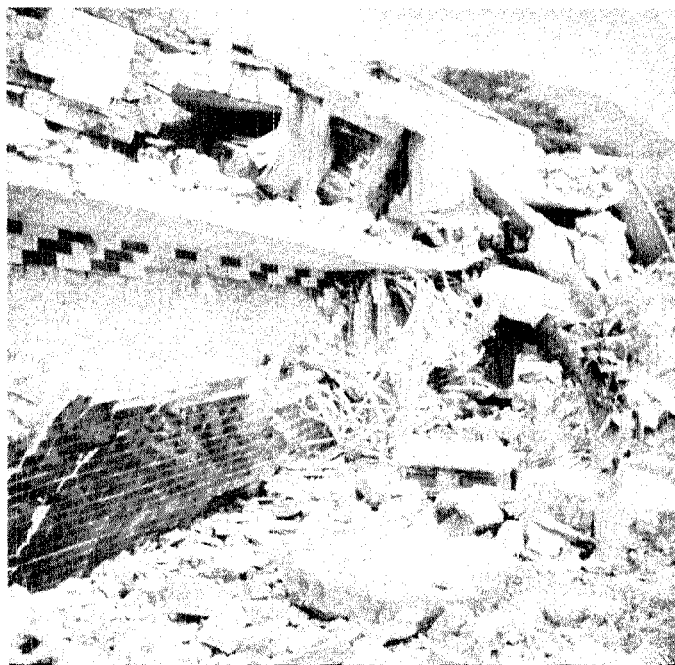
One house deserves particular mention. It was situated alongside the highway about halfway between Rio Blanco and Orizaba. The house was 13 years old and was of two stories, split-level, with a garage basement. It collapsed completely, fortunately after the residents had been able to escape. The building provided the first example of what later proved to be a rather common mode of failure, namely, the failure of the torsionally unbalanced building. Along one side (see Figure 5, p.18) long columns supported the building, while on the other side, short columns were used (see Figure 6, p. 18 ). Consequently, the center of stiffness was located away from the center of mass.

Figure 6 Collapse of two-story house  
between Rio Blanco and Orizaba.

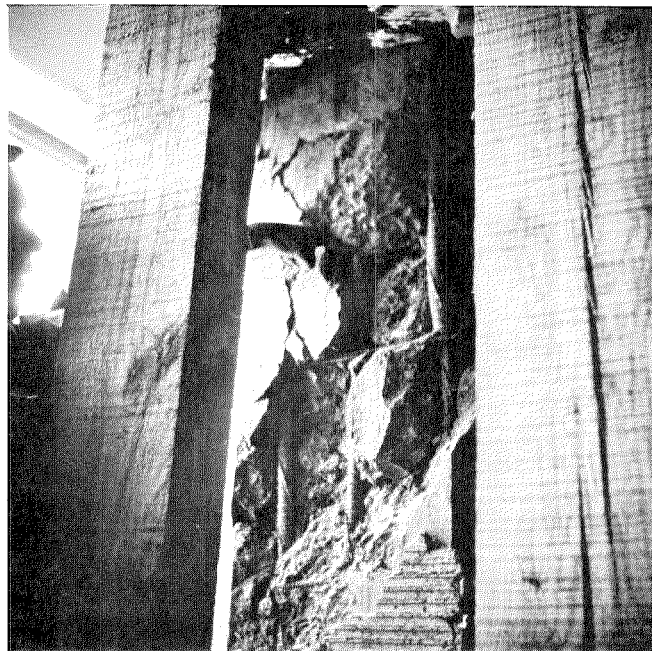
A. Social Security Hospital. — The Social Security Hospital is a modern, 7-story structure built in 1958. The building is divided into three parts by construction joints on either side of the elevator shafts and access stairways. The main frame consists of reinforced concrete columns and floor slabs, with unreinforced brick and mortar filler walls (see Figure 8, p. 19). The hospital suffered major secondary damage. In fact, the secondary damage was so severe that the top five floors were unusable. On each of these floors there was a terrific mess of broken wall tiles, reagents, hospital equipment and fractured secondary walls which, although unreinforced, had not been isolated from the main frame. Fortunately, the rest of the hospital was operational, although the staff were sorely pressed at a time when every inch of the hospital was urgently needed. The main frame of the hospital suffered little damage. The floor slabs had cracked on some floors and some of the columns had spalled (see Figure 9, p. 19 ). Figure 10 (p. 20) shows evidence of some working of the construction joints. However, plumb-line checks revealed that no permanent lateral displacement had taken place.

Figure 9 Spalled column, Social Security Hospital. Notice spacing of stirrups.

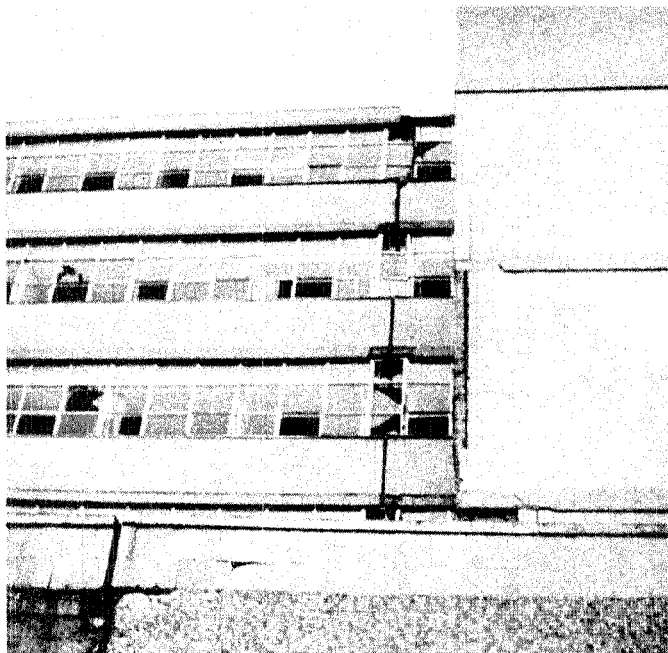
Figure 10 Working of a construction joint,  
Social Security Hospital.

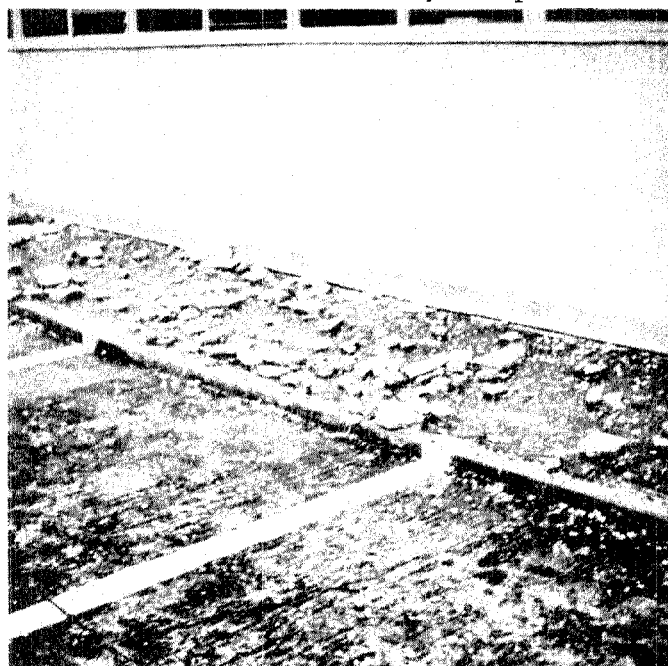
Settlements of 10-15 cm. had occurred in the filled ground in the parking lot in front of the hospital (see Figure 11, p. 20 ).

Figure 11 Soil settlement in parking lot,  
Social Security Hospital.

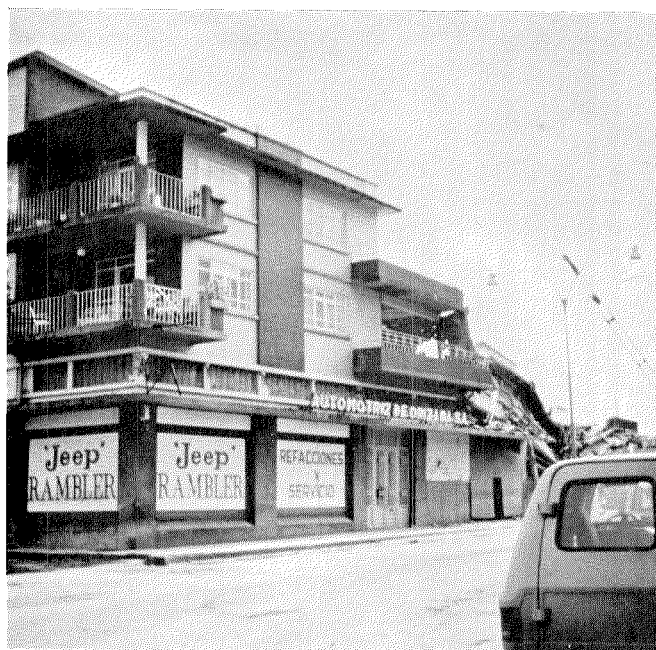
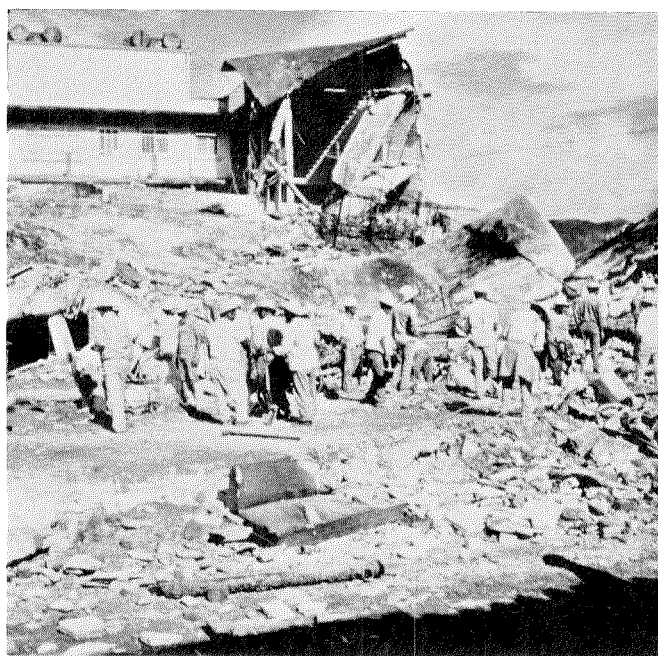
B. The "Packard" Apartment Building. — The complex consisted of three, three-story buildings linked by terraces and stairways. Two of the buildings collapsed killing ten people, injuring 40 and crushing 20 cars parked underneath on the ground floor (see Figures 12 and 13, p.21). The end of the building, still standing, was markedly stiffer than the other part which appeared to have been supported on slender columns (see Figure 14, p.22). Notice also, the flexural-shear failure of the short columns which provided the ventilation gap for the ground floor shops (see Figure 15, p.22). The whole complex was torsionally unbalanced because of the linking terraces and stairways which provided shear transfer between adjacent buildings.

Figure 13 Collapse of "Packard"  
apartment building, Orizaba

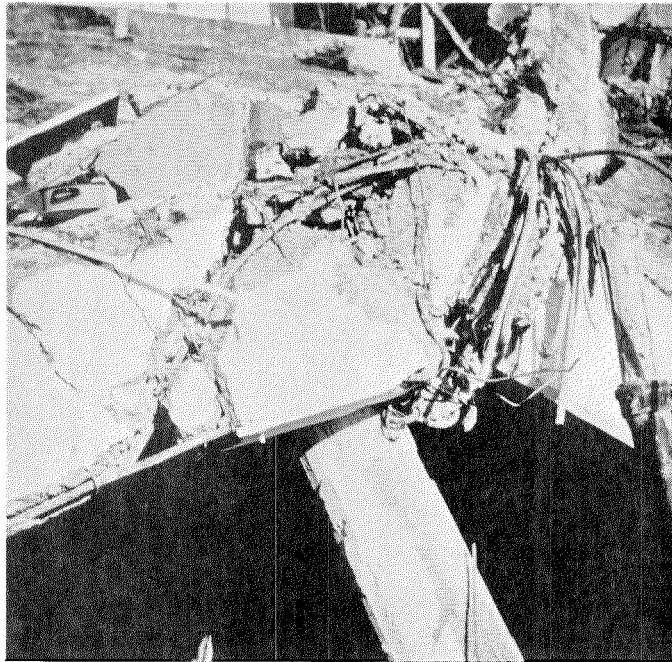
Figure 14 Beam-column failure,  
Packard apartment building.

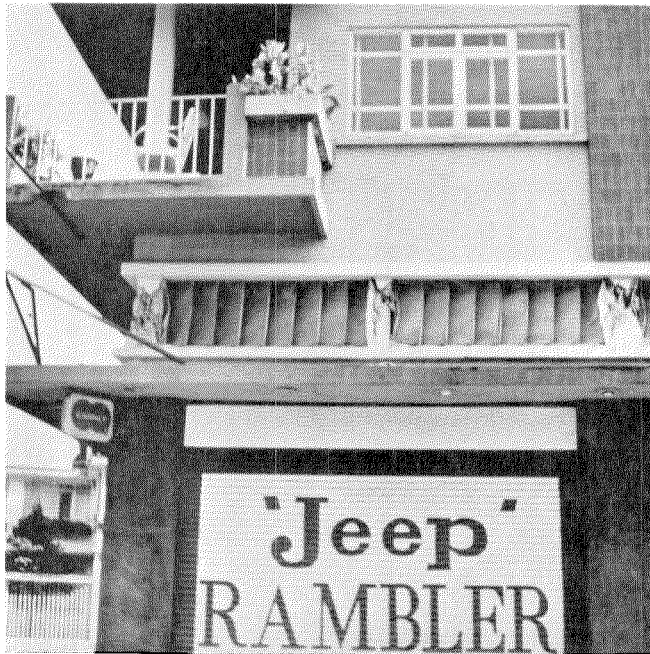
Figure 15 Failure of short columns, Packard  
apartment building.

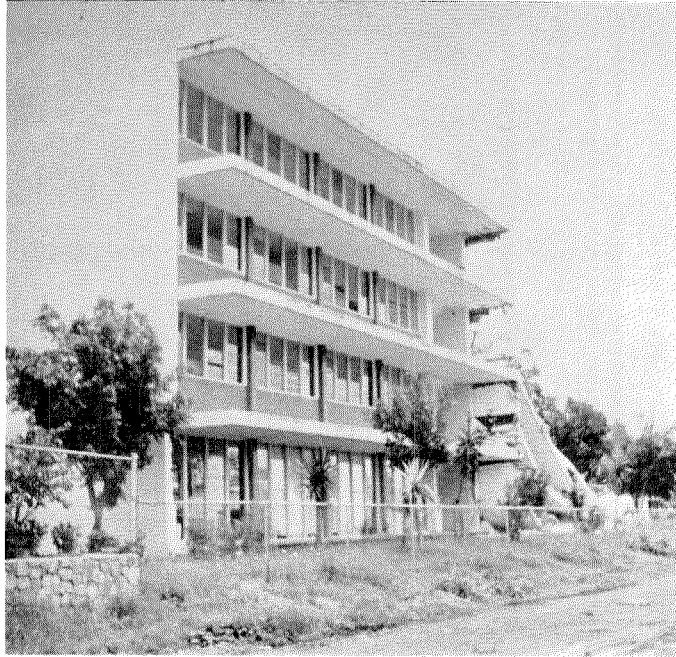
C. Technologico of Orizaba. — This modern complex of school buildings is situated on the outskirts of Orizaba and provides tertiary technical education and training for the area. Two four-story classroom blocks had been extensively damaged. The buildings had reinforced concrete frames and floor slabs, and brick filler walls. Other single-story buildings on the site had suffered little damage. The first four-story building (Building A) shown here consisted of two parts linked by stairways. Half of the structure collapsed completely (see Figures 16, 17, 18, pp.23, 24). Along the shorter sides adequate stiffness had been provided by four brick and mortar shear walls, but the building was weak along its major direction. Indeed, the rectangular columns were oriented so that their weak direction was parallel

Figure 16 Collapse of classroom block  
(Building A), Technologico of  
Orizaba.

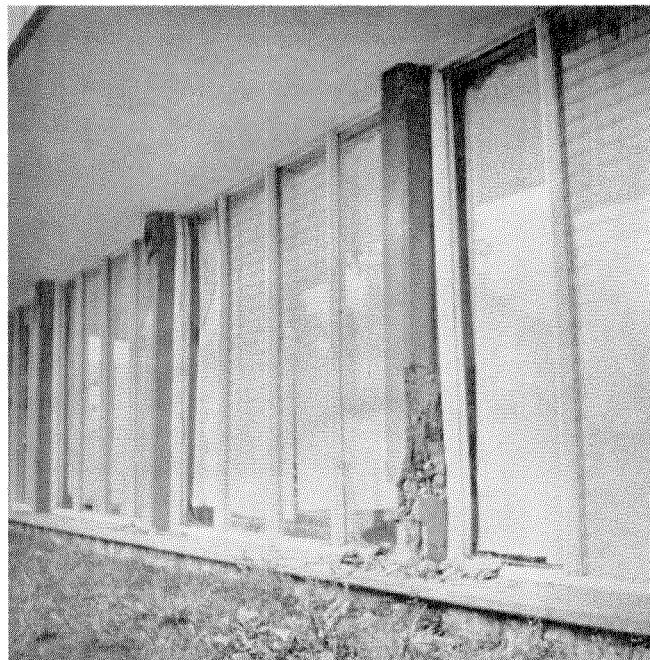
to the longer side; in plan, the column depth was approximately twice the width. Flexural-shear failure of the ground floor columns precipitated the collapse (see Figure 19, p.24 ). Figure 20 (p. 25 ) shows the behavior of post-tensioned floor slabs. The hollow cardboard cylinders had been placed in the floor to save weight, but they were instrumental in the slabs losing any continuity which the prestressing cables might have provided. It is most fortunate that the earthquake occurred before school had started for the day.

Figure 19 Failure of ground floor columns, Building A, Tecnologico de Orizaba.

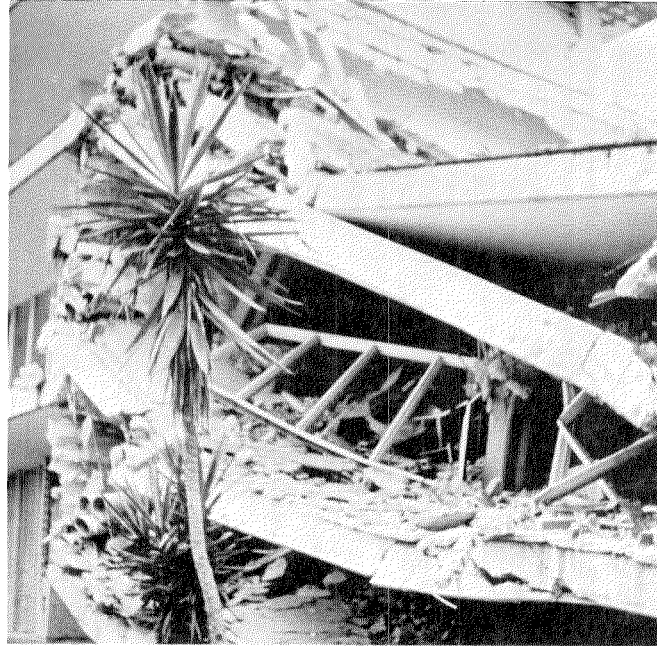
Figure 20 Behavior of floor slabs, Building A, Tecnológico de Orizaba.

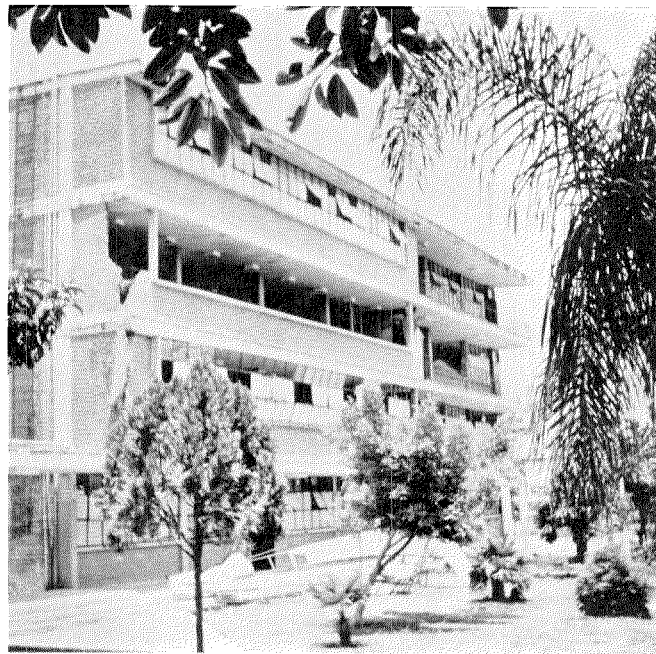
The other four-story building (Building B) remained standing, although it is likely that it will have to be completely rebuilt (see Figure 21, p. 25). Superficially, this building appeared to be similar to Building A; it was of the same height and plan area and stairways separated the building into two parts. However, closer examination revealed major structural differences. The center of mass of the building was towards the left-hand end, while the center of stiffness was nearer the stairway (see Figures 21 and 22, pp.25,26). Hence, the building responded primarily in torsion. Good evidence of this is provided by Figure 23 (p. 26 ) which shows classical torsional cracking of a second-story column located adjacent to the stairway.

Figure 21 Damage to classroom block (Building B), Tecnológico de Orizaba.

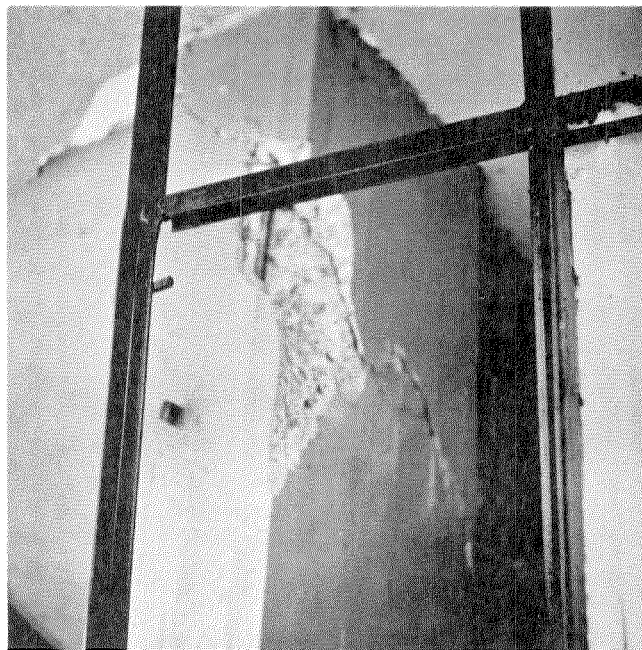
Figure 23 Torsional cracking of second story  
column, Building B, Technologico  
of Orizaba.

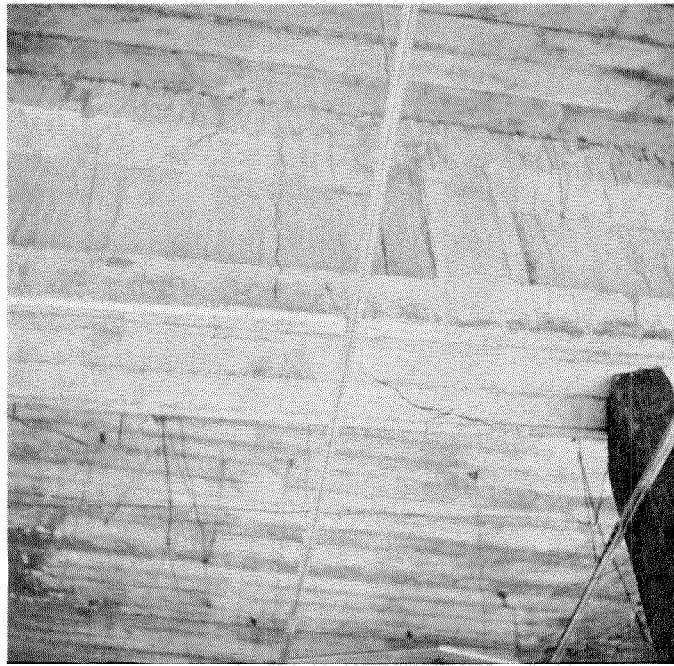
point indicated that the roof beams were under-reinforced, and had cracked under the bending moments induced by the vertical vibrations of the roof (see Figure 26, p. 28 ).

Figure 26 Flexural cracking at midspan of roof beam, VW Garage Showroom, Orizaba.

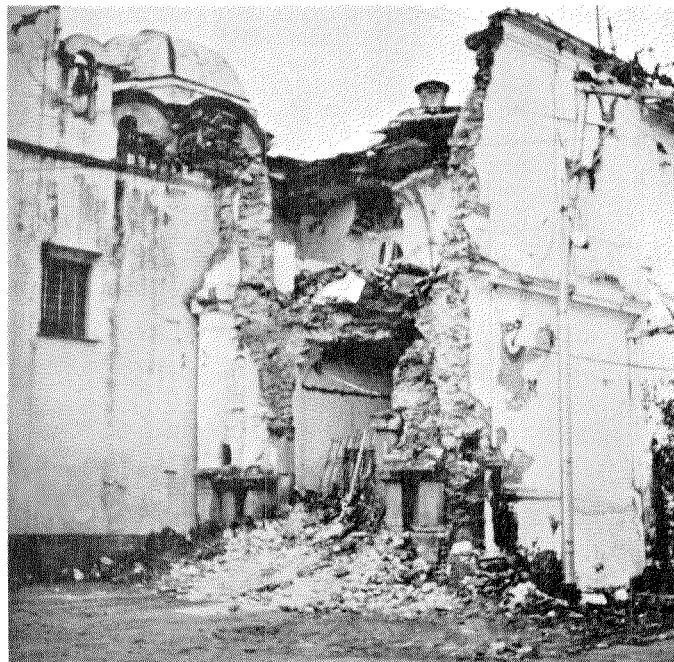
E. Other buildings. — Damage to churches in the area was extensive. These buildings were generally old, sometimes as much as 300 years old, and usually were built of stone or brick with clay or cement mortar. Walls, spires and arch roofs had frequently collapsed. Figure 27 (p.28) shows typical damage to a church-hospital in Orizaba.

Figure 27 Damage to a church-hospital in Orizaba.

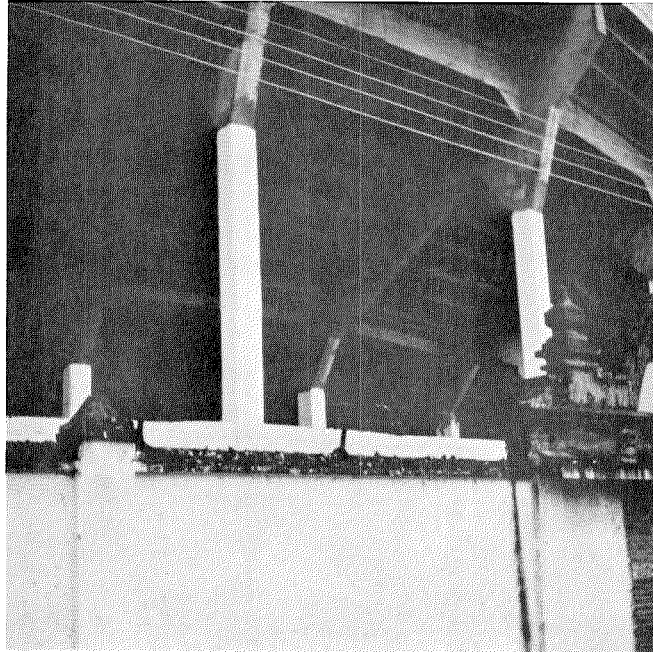
Orizaba's bull ring survived the earthquake with practically no damage. However, Figure 28 (p. 29 ) shows a plastic hinge which had formed in the column at an interior beam-column joint, again due to short column effects.

Figure 28 Plastic hinge formation at an interior column, Orizaba Bull Ring.

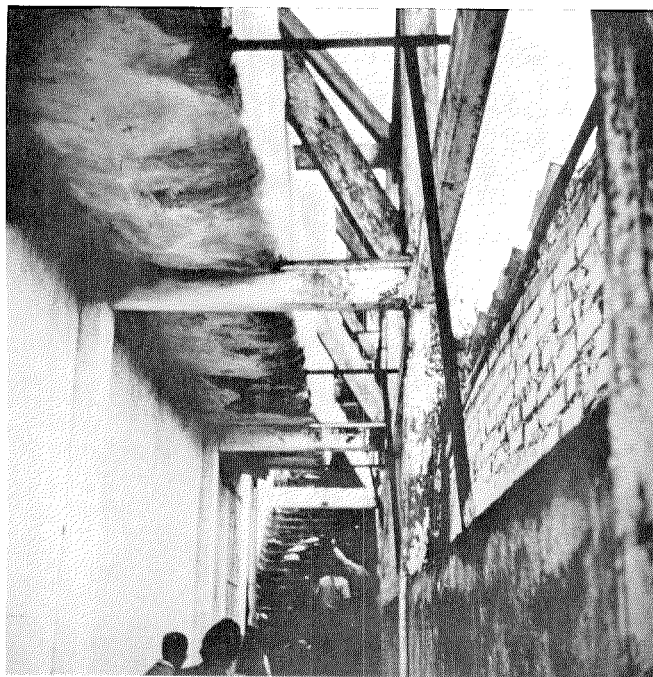
There was some damage to cinemas in Orizaba. In the case of the Cinema Real, the reinforced concrete buttress frame had been pushed out by the roof load. (See Figure 29, p. 29 ).

Figure 29 Damage to buttress frame, Cinema Real, Orizaba.

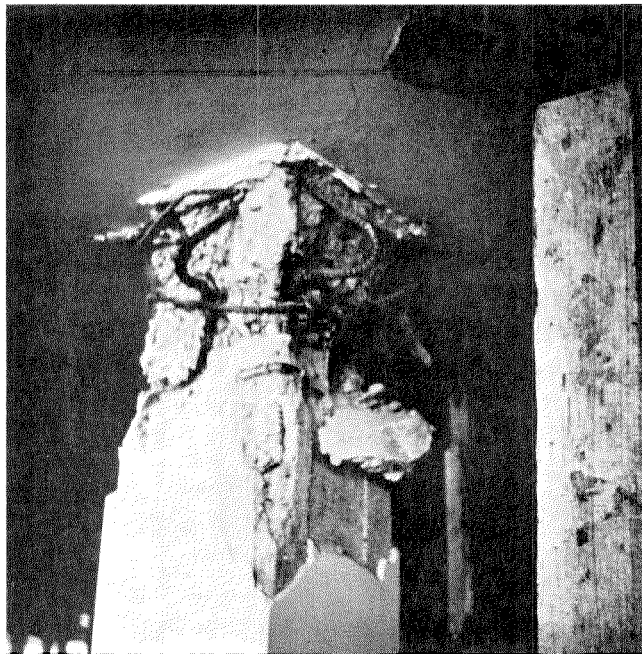
A. Five-Story Business House. — The failure of this building was one of the most interesting, from an engineering standpoint. This building, which had a reinforced concrete frame with brick filler walls, is owned by Mr. Kushida, a Japanese businessman, and was built in 1968. The bottom three floors house shops, offices and warehouses, whereas the top two floors, which are set back (see Figure 30, p. 30 ), are occupied by Mr. Kushida and his family. The overturning moment resulting from the motion of the top two floors caused axial compression failures of columns on the third floor (see Figure 31, p. 30 ). The upper floors had dropped approximately 30 cm. Damage to the

Figure 31 Axial compression failure of third-floor column of business house, Córdoba.

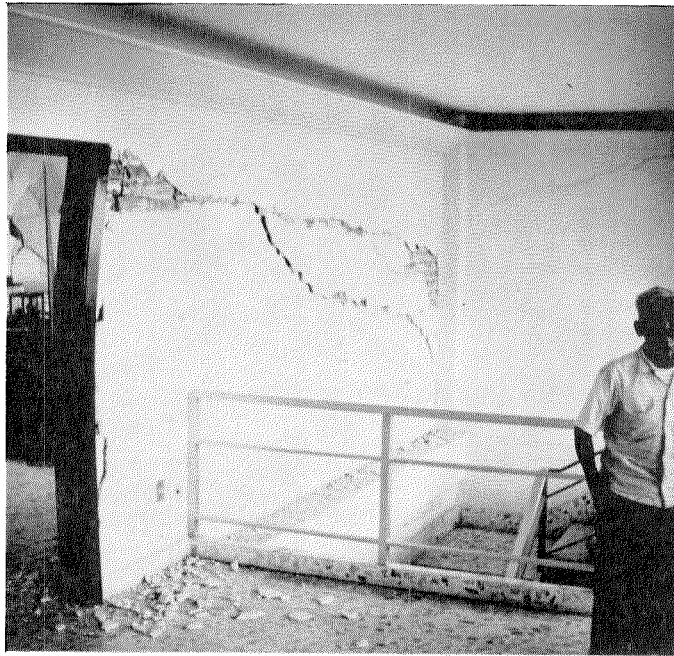
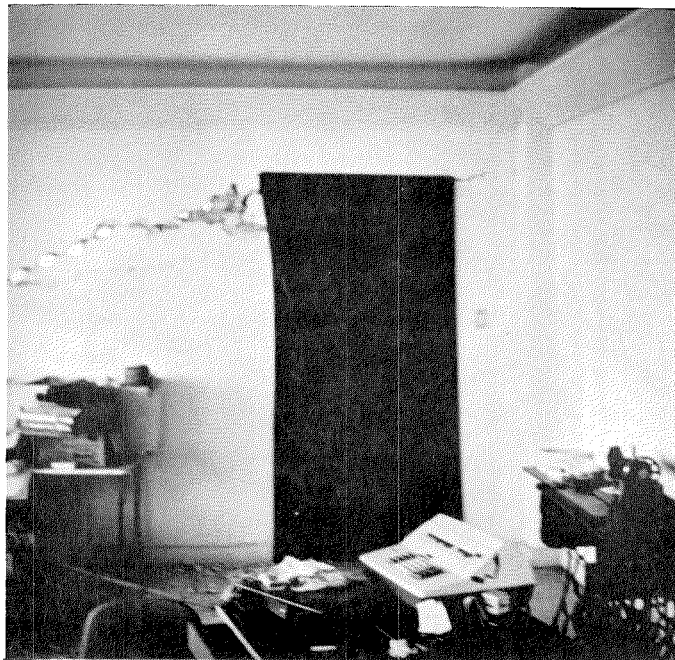
three upper floors was severe. Figures 32 and 33, (p.31) show damage to brick and mortar walls on the fourth and fifth floors; the plywood door was buckled in shear. Goods stored in this building were subsequently damaged by heavy rainfall.

Figure 32 Damage on upper floors of business house, Córdoba.

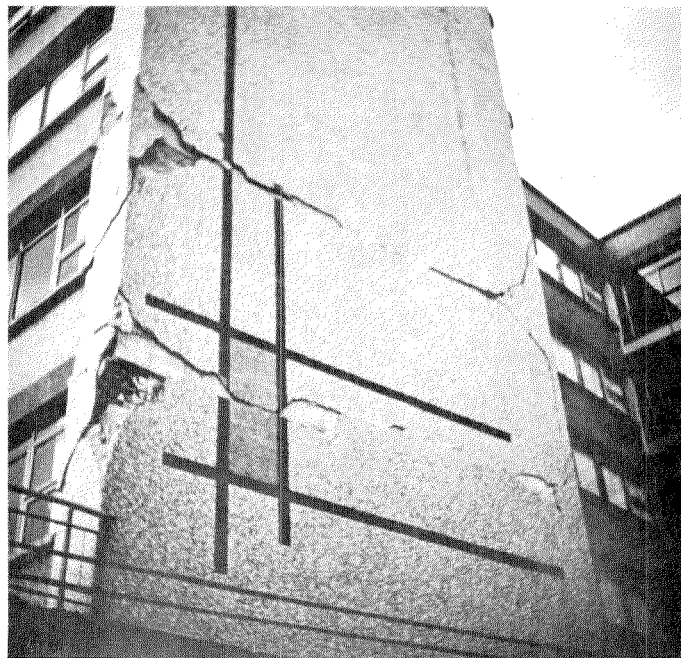
B. Hotels. — The Hotel Trueba, which has a reinforced concrete frame with brick filler walls, suffered extensive secondary damage, mainly to unreinforced brick and mortar walls which had been made continuous with the structural frame. The six-story shear walls showed evidence of cracking at the second and third floors (see Figure 35, p. 32). This could indicate some second-mode response to the excitation. However, this seems unlikely since the participation factor for second-mode response is usually too small to be significant. The building is more likely to have responded strongly in the first mode, in which case local weaknesses in the construction at the second and third floors could have led to the cracking which occurred there. Another possibility is that the wall behaved as a coupled shear wall (the coupling between the two columns being provided by the floors and the infill walls) where, typically, laminar shear stresses attain their maximum values about one-third of the way up the shear wall.

Figure 35 Cracking in shear wall, Hotel Trueba.

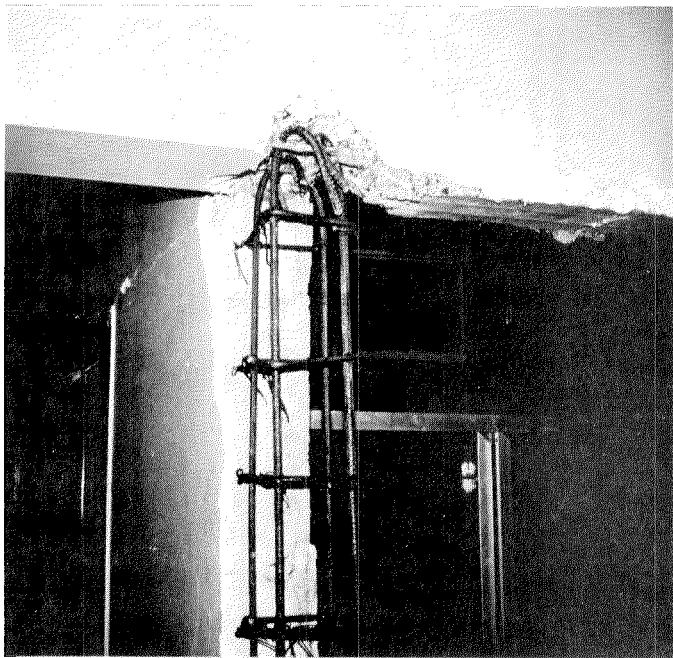
For whatever reason, the behavior of the wall is peculiar since Figure 34 (p.32) shows an obvious zone of weakness at the level of the ground floor columns. Yet inspection showed no sign of damage to these columns. It can only be concluded that sufficient stiffness was present in the ground floor to avoid damage there. Figure 36 (p.33) shows a typical interior beam-column joint. Since many of the rooms in the hotel were uninhabitable owing to broken partition walls, the owner was very keen to have repairs made as soon as possible. Unfortunately, the philosophy behind the repair scheme left much to be desired, as Figure 37, (p.33) shows.

Figure 37 Repair scheme for partition wall, Hotel Trueba.

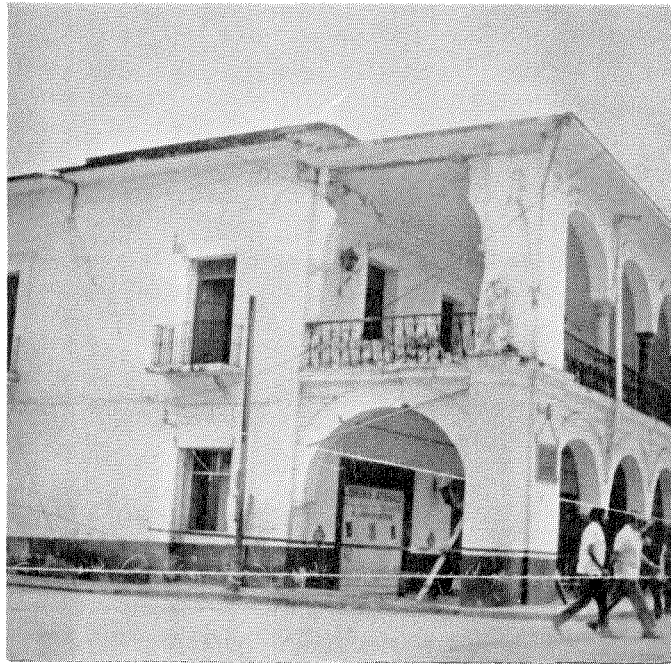
The Hotel Zevallos is one of the oldest buildings in Córdoba, having been built in 1687, just 70 years after the Spaniards founded the town. Although the exterior of the building has changed somewhat (see Figure 38, p. 34) and a reinforced concrete roof was placed earlier this century, the interior courtyard is substantially unaltered. The view of the all-but-failed three-way arch (see Figure 39, p. 34) is taken from this courtyard. It appears that the roof slab saved the outer corner of the building from collapsing.

Figure 38 Damage to exterior corner of the Hotel Zevallos, Córdoba.

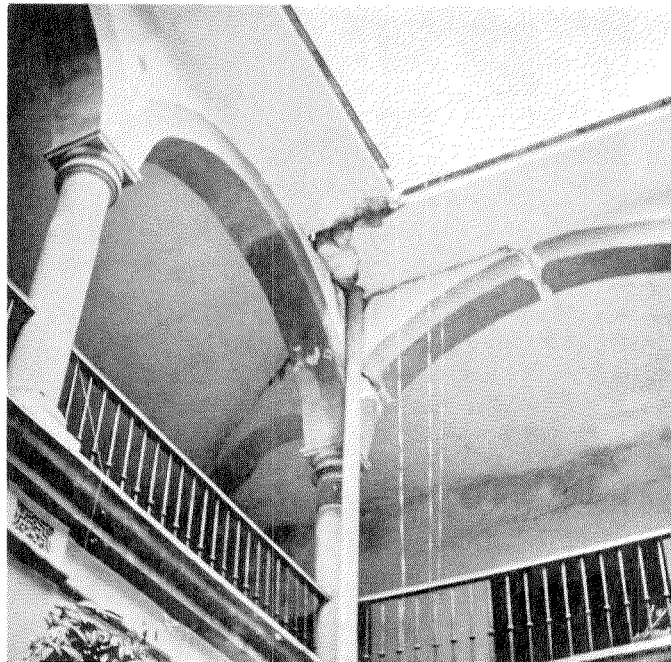
Figure 39 Damage to three-way arch, interior courtyard, Hotel Zevallos.

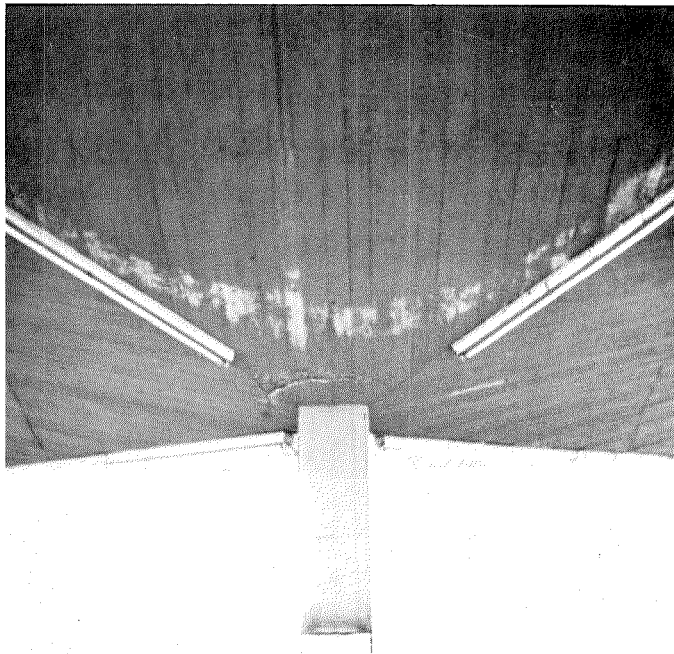
C. Service Station Shelter. — The cantilevered service station shelter shown in Figures 40 and 41 (p.35) had cracked at the junction of column and roof slab. It appears that the rotary inertia associated with the roof had been ignored in the design. The rotary inertia had two effects: first, under horizontal excitation the true bending moment diagram is trapezoidal, not triangular; secondly, the rotary inertia may so lower the fundamental frequency that an earthquake may cause strong excitation of what, at first, appears to be a relatively stiff single-story structure. Punching shear may have contributed to the behavior of the shelter, although the cracking did not extend to the other side of the column junction.

Figure 41 Damage to service station shelter.

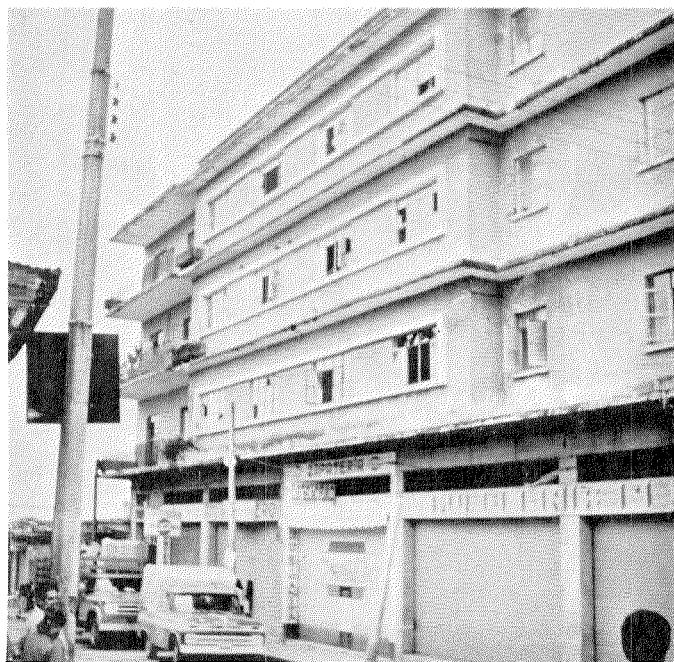
D. Other buildings. — The four-story apartment building shown in Figure 42 (p. 36) housed some 150 persons. It had survived the earthquake but was in imminent danger of collapse owing to severe damage to the main structure. The building had been evacuated, and was soon to be demolished.

Figure 42 Apartment building, Córdoba. There was extensive internal structural damage to this building.

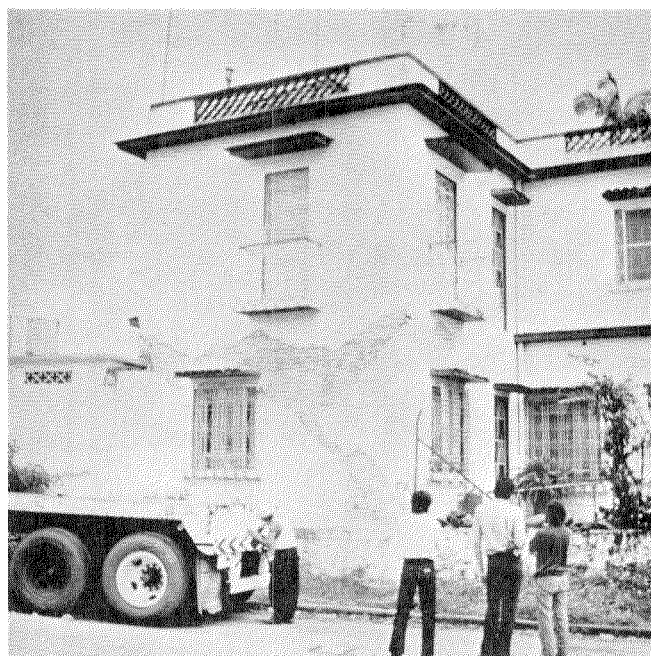
Figure 43 (p. 36) shows typical damage to one of the better constructed houses in Córdoba. The next three views (Figures 44, 45 and 46, pp. 37, 38)

Figure 43 Typical damage to a better constructed house, Córdoba.

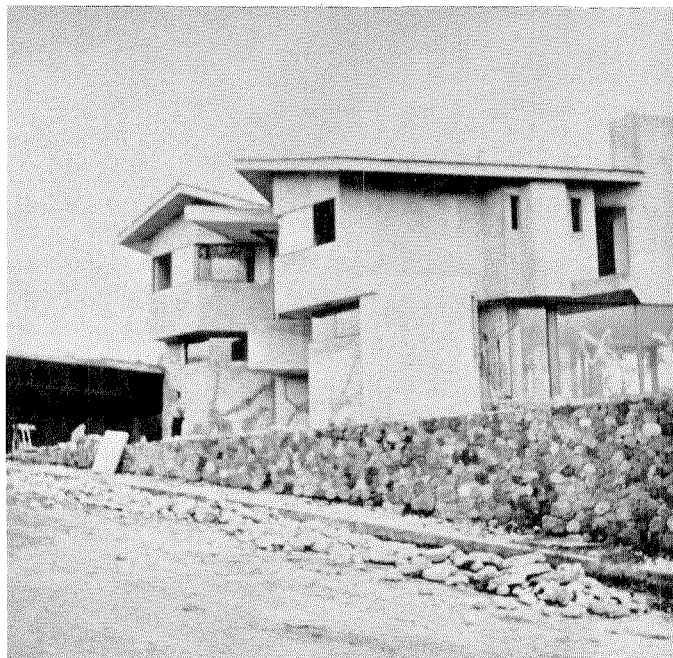
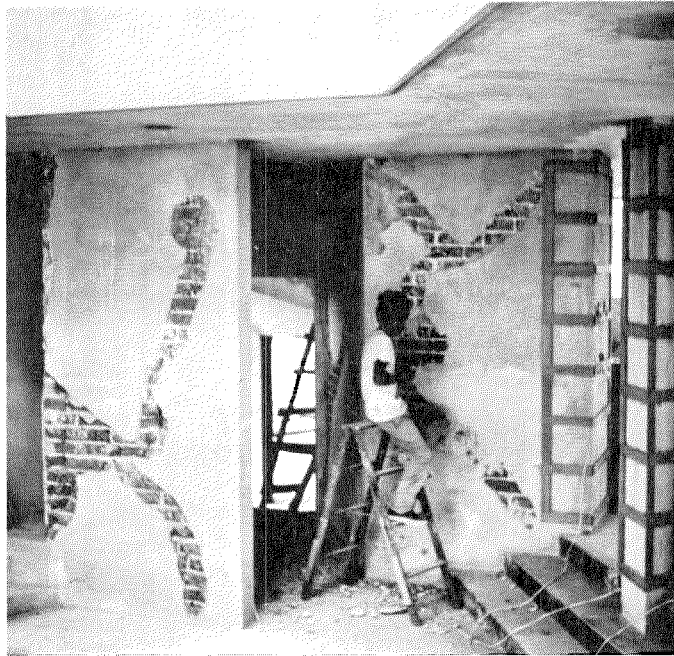
show damage to an architecturally modern house on the outskirts of Córdoba. The house is torsionally unbalanced, and it appears that very little attention had been given to engineering details.

Figure 45 Damage to exterior walls of house.

Figure 46 Damage to interior walls of house.

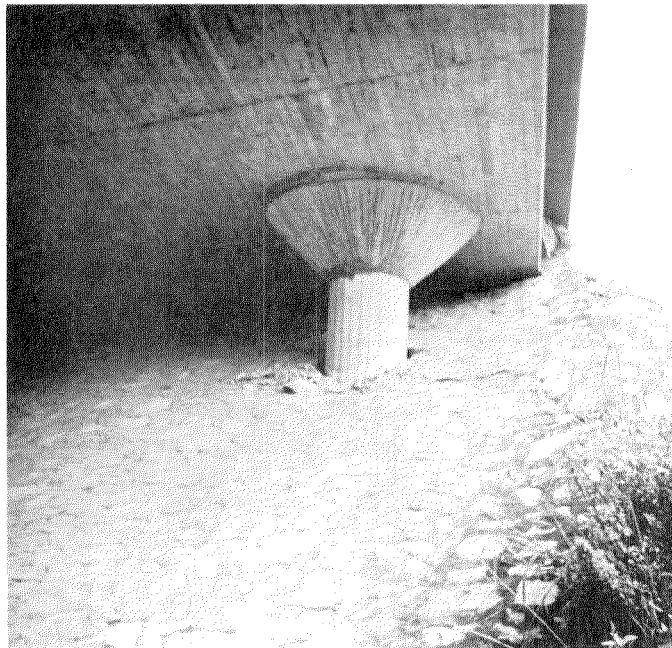
About 15 cm. of settlement of an embankment occurred around the piers of this freeway bridge between Córdoba and Orizaba (see Figure 47, p. 38). There was no sign of any cracking in the bridge deck.

Figure 47 Settlement of embankment around bridge pier, Córdoba.

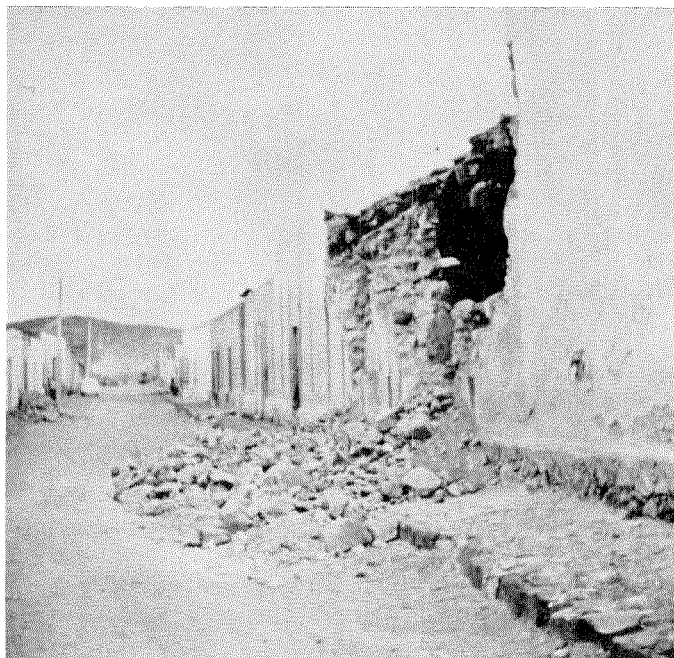
The City of Serdán was the last visited. It was clearly the worst hit by the disaster, with perhaps 300 deaths and many of the homes were damaged or destroyed. Serdán is a very poor agricultural town, and the houses consisted of walls of stone and clay mortar and tile roofs. Figure 48 (p.39 ) shows typical damage to such buildings. It appears that the town is too poor to finance an adequate rehousing project, and the Federal Government will have to assume responsibility for the rebuilding. In the meantime, some of the houses, which were only partially damaged, will be rebuilt using the age-old methods. Consequently, the next strong earthquake will again wreak havoc in the town. The pattern is, unfortunately, all too familiar in the country areas of Latin America.

Figure 48 Typical view of damage to houses in Serdán.
